NW – A85 Fowlis Wester to Gilmerton

Bear Scotland Landscape.

NW – A85 NEAR FOWLIS WESTER TO GILMERTON

To look at failing and leaning trees in this location in Transport Scotland and Landowner Areas, and complete visual report with a summary action.

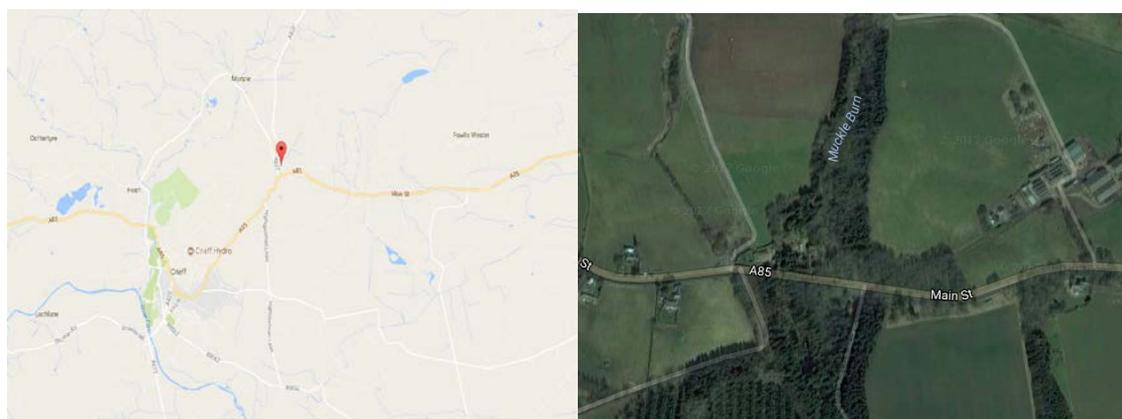
1. Woodland Area – Inspection 18/06/17

The Woodland Area sits on the North Side of the A85, to the East of Gilmerton. Near the Abercairny Estate Offices.

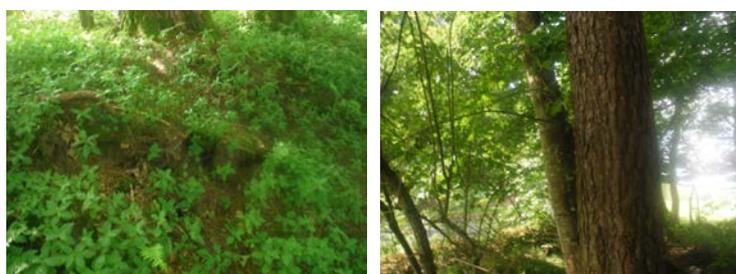
Picture trees and root.

- A. After inspection of the location on 20/06/17, there are 2 trees noted that have immediate leaning issues and as a result of evidencing tree root lifting, have advised the owner and factor that these should be felled immediately.

The 2 potentially dangerous trees at the west corner that could come down in the next gale, were visited by the Landowner and the Factor. Bear Scotland Ltd offered Traffic Management and support, and advised that these be attended to as a matter of priority.

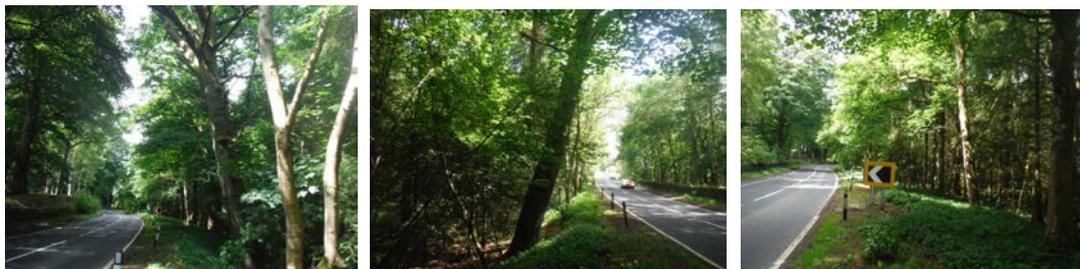
Pictures trees

- B. The Woodland sits in wet conditions for part of the area, many trees within the Woodland are failing some have blown over during the years. Approx. 12 trees appear to have a reasonable lean towards the road, and recommendation would be to fell as soon as possible, due to any unforeseen gales.

The Landowner has been advised that trees within the woodland are a potential issue, and he suggested that he would look at best felling options.

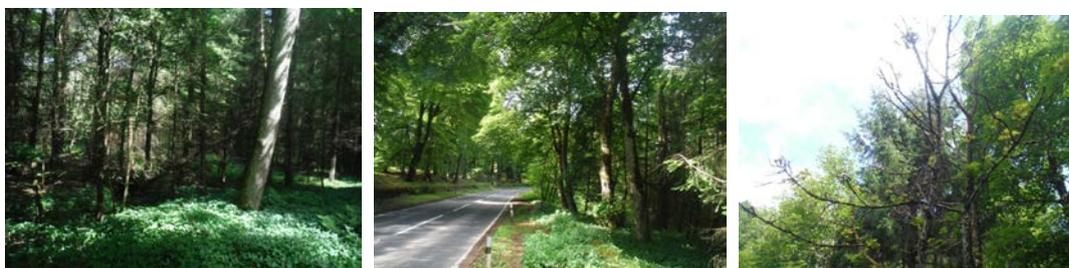
Pictures on edge of Woodland.

- C. The rest of the woodland would be advised for felling as the impact of the creating open areas within may cause other trees within the woodland to blow.

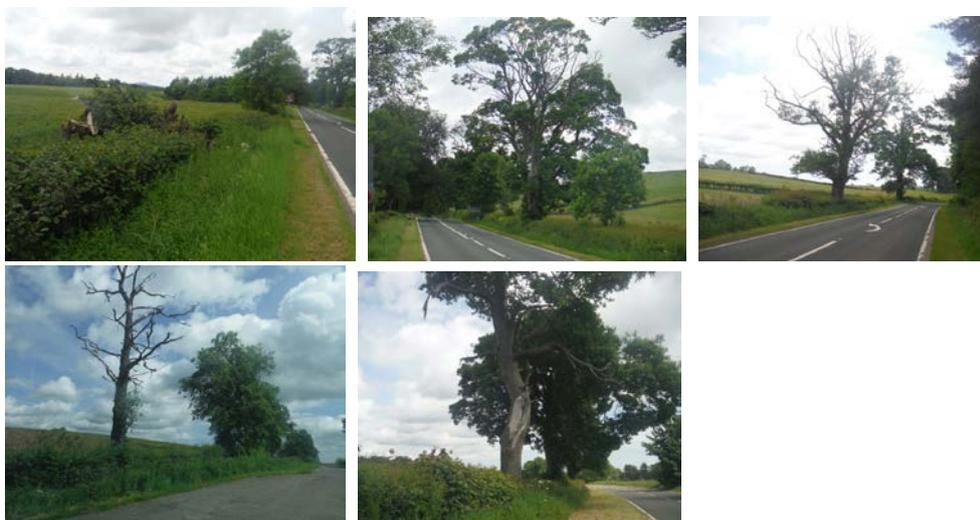
Pictures.

- 2. There also appears to be a potential issue with various trees on the hedge lines from Methven to Gilmerton, some of which have had fallen branches and some windblown.

- A. The Line of Statement trees which run with the hedgeline appear to have been affected by wind, poor growth, spraying etc and there are many with potential issues.
